# IMACS SITE FORM

4. State Utah State Code 42 County Summit County Code SM  
 5. Project Victory Ranch Phase III P-III Associates Project No. 5196  
 \*6. Agency Report No. U-03-PD-0248p P-III Associates Report No. 5196-01-20305  
 \*7. Site Name / Property Name Prescott Ranch / Victory Ranch Bridge

## HISTORIC SITE FORM

Name of Property: Prescott Ranch/Victory Ranch Bridge Site Nos. 42SM460/42WA361  
 Address: Off Lower River Road Temporary Site Nos.: 5177-08/5196-02  
 City, County: Wasatch/Summit Township: 2S Range: 6E Section: 32  
 UTM: 475513E / 4494268N  
 Current Owner Name: Horizons Unlimited LC USGS Map Name & Date: Francis, Utah 1967  
 Current Owner Address: 2252 Lenwood Ct. SW  
 Address: Rochester, MN 55902  
 Tax Number: CD-2056-6  
 Legal Description (include acreage): SE1/4 of NE1/4 of SW1/4 (0.04 acre)

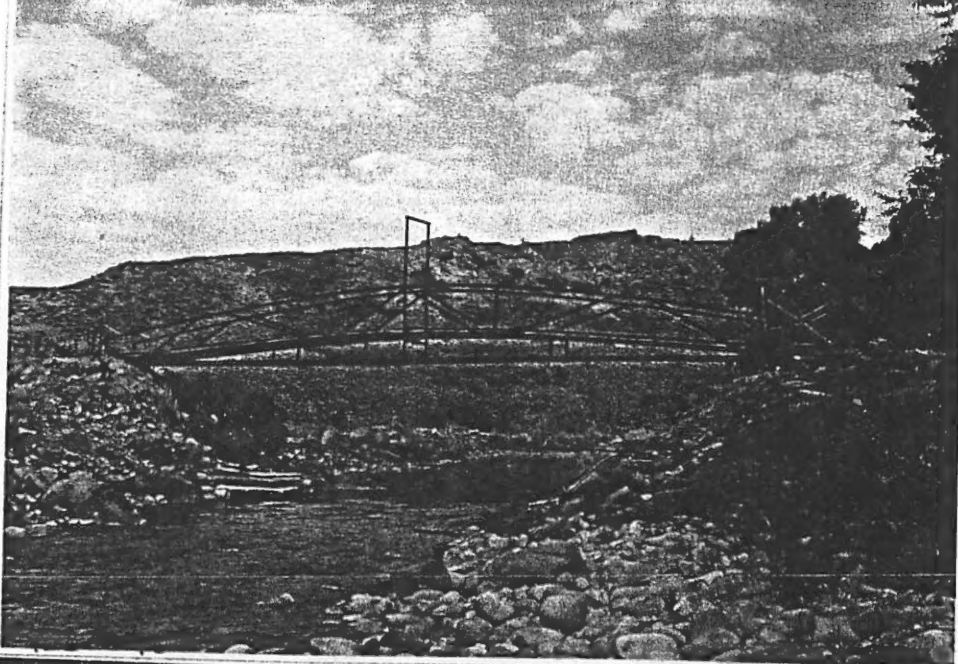
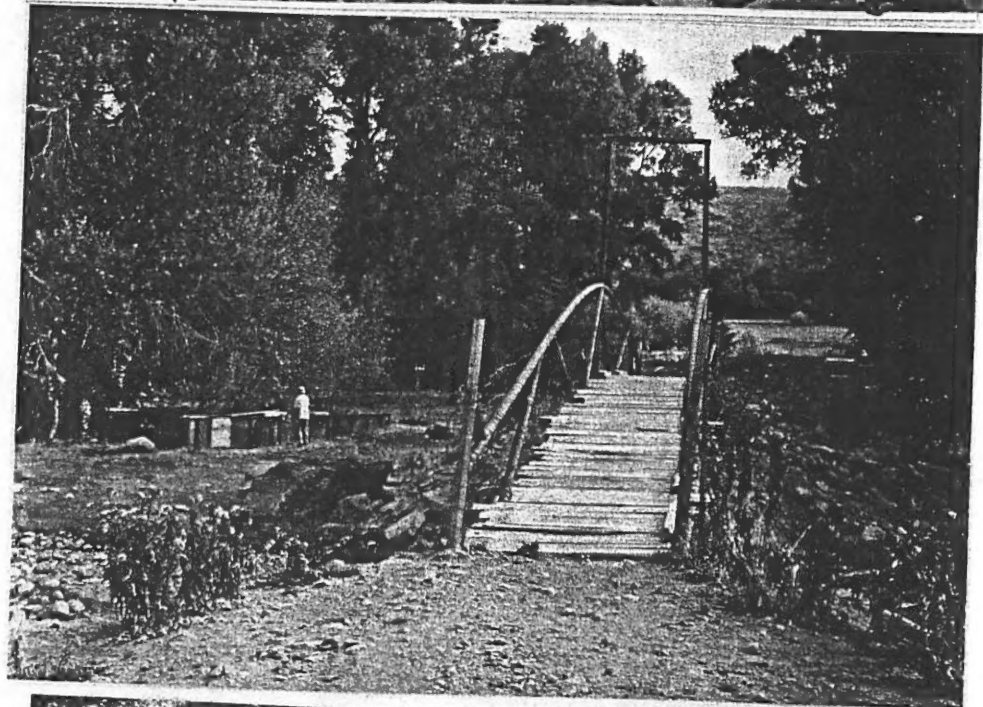
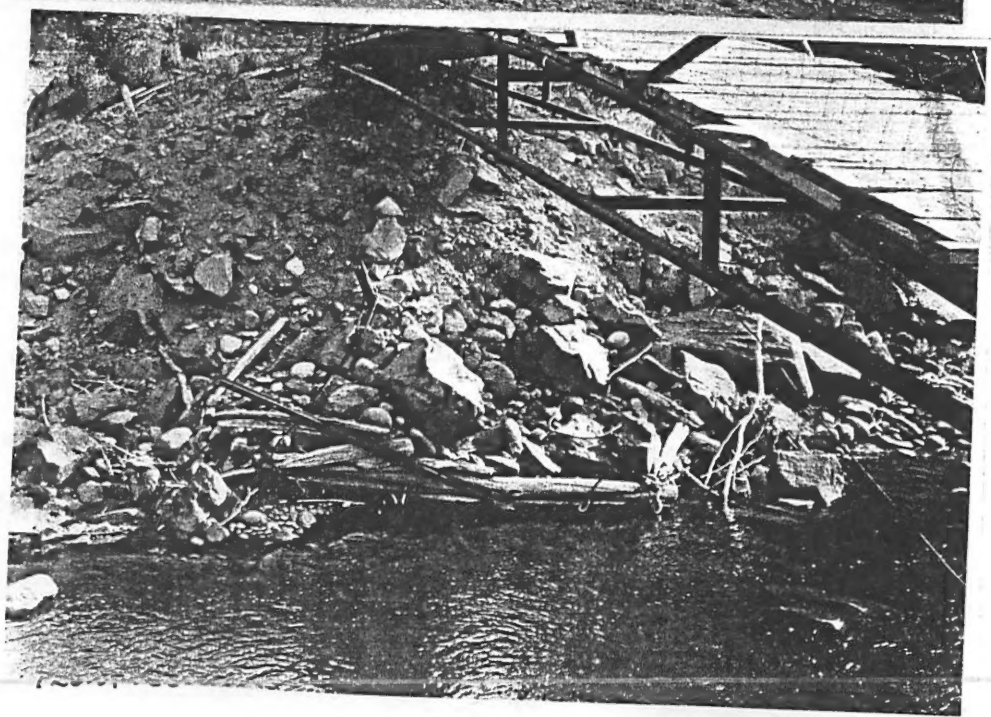
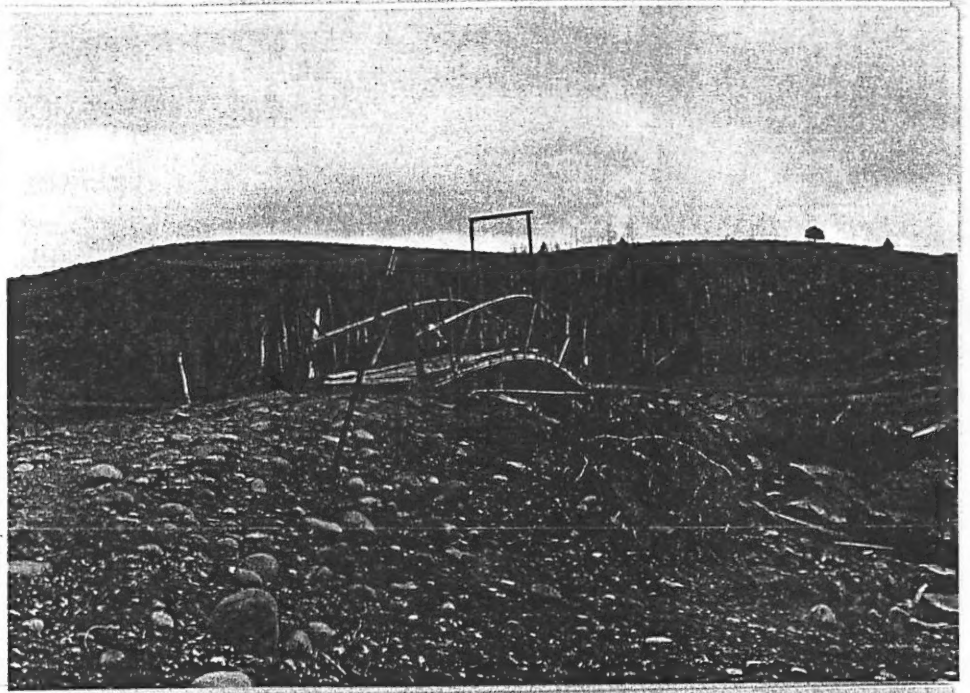
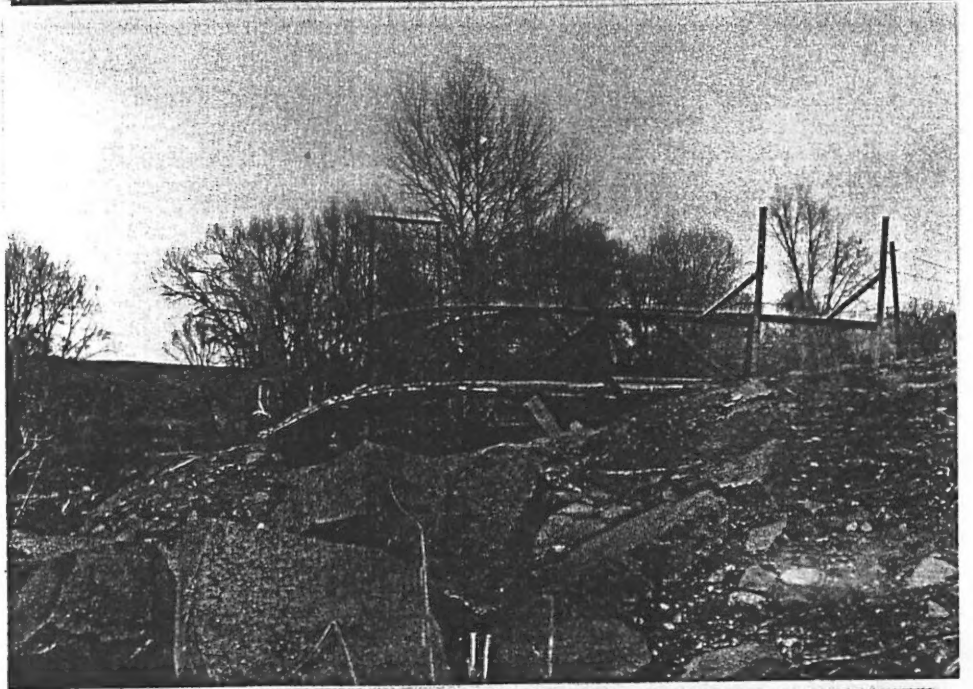
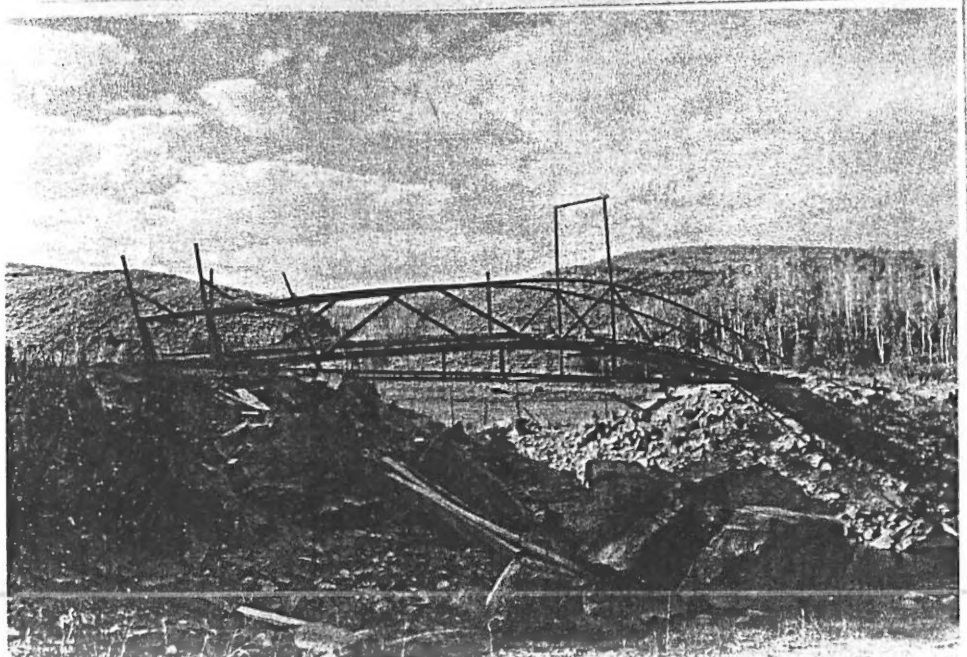
The original bridge was dismantled and replaced. The current bridge has a decaying wood deck and is in fair condition. The original bridge foundation is partially eroded and is in fair condition.

24. Photos	Date	Roll No.	Neg. No.	Item No.	Caption
	9/21/200	01-27	02		Bridge facing southwest from northern side of Provo River.
	9/21/200	01-27	03		Bridge facing northwest.
	9/21/200	01-27	04		Bridge facing northeast. R. I. Bimie is at original (vehicle) bridge span.
	9/21/200	01-27	05		Detail of original wooden footings, facing west-northwest.
	4/23/200	87	21a		Overview of bridge from northern side of river. Photo faces southwest.
	4/23/200	87	22a		Overview of bridge from southern side of river. Photo faces east-southeast.

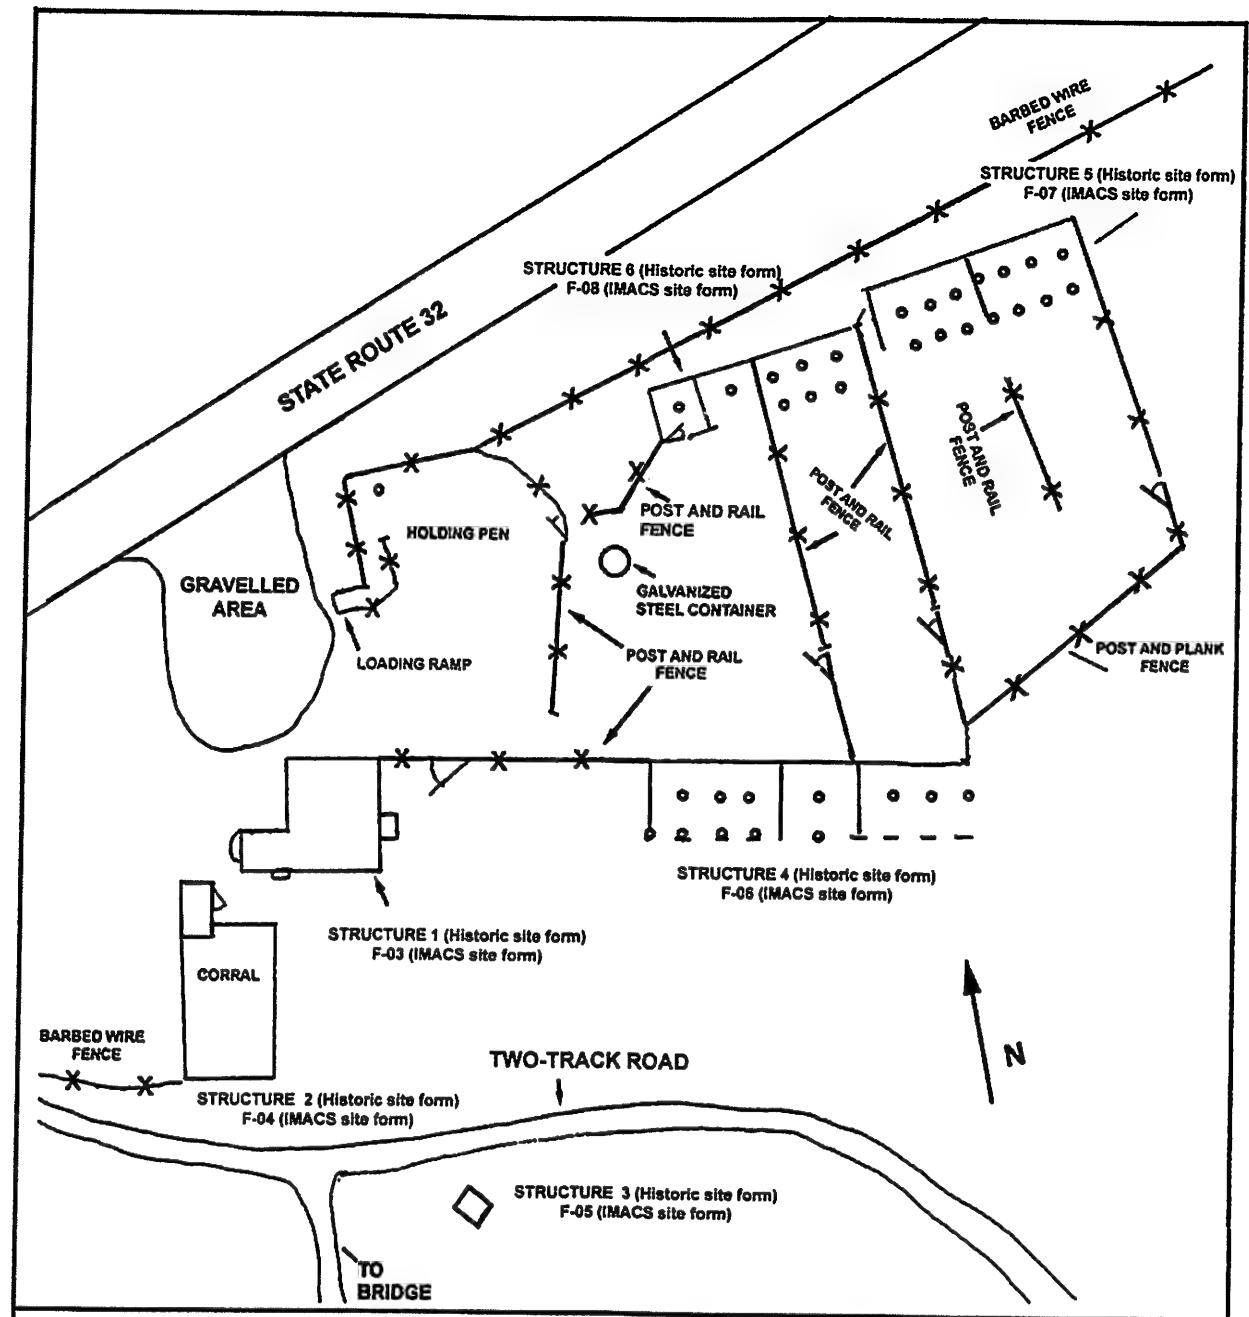
**Site 42WA324  
Larsen Farmstead  
(Larsen Ranch Complex)  
Plan Map**

The site has been impacted by erosion, a two-track road, vandalism, grazing, rodent burrowing, fencelines, and vegetation growth. The earlier barn (F-01) is in poor condition and is currently in danger of collapsing to the south. An associated pen (F-02) is collapsed and two associated corrals are in poor condition. The red barn (F-03) is still standing and is structurally sound; however, portions of the roof have collapsed and the interior is covered in cow manure. The pens and structures associated with the red barn (F-04 to F-08) are in fair to good condition. The bridge (F-09) is in good condition, although the eastern end of the central concrete bridge support has sunk slightly into the bed of the Provo River. The collapsed corral (F-10) is in poor condition. The stockpond (F-12) and irrigation ditch (F-11) are currently not in use and are in fair to good condition. The small house (F-13) retains structural integrity and is in fair condition. A tree has fallen across the rear portion of the structure since the initial architectural documentation. The garage (F-14) is in good condition. The pumphouse (F-16) and the root cellar (F-15) have collapsed roofs and portions of the walls are also collapsed. They are in fair condition. The rubble pile (F-17) represents the remains of a destroyed house obviously in very poor condition. The outhouse depression (F-18) is in fair condition, although there is no evidence of the original superstructure. The remainder of the site has little evidence of any disturbance and is in good condition.
